The pink staircase of Sully-sur-Loire castle: Even bacteria like historic stonework

Johann Leplat, Faisl Bousta, Alexandre François, Mikael Guiavarc'H, Jean-Didier Mertz, et al.. The pink staircase of Sully-sur-Loire castle: Even bacteria like historic stonework. *International Biodeterioration and Biodegradation*, 2019, 145, 10.1016/j.ibiod.2019.104805 . hal-02470673

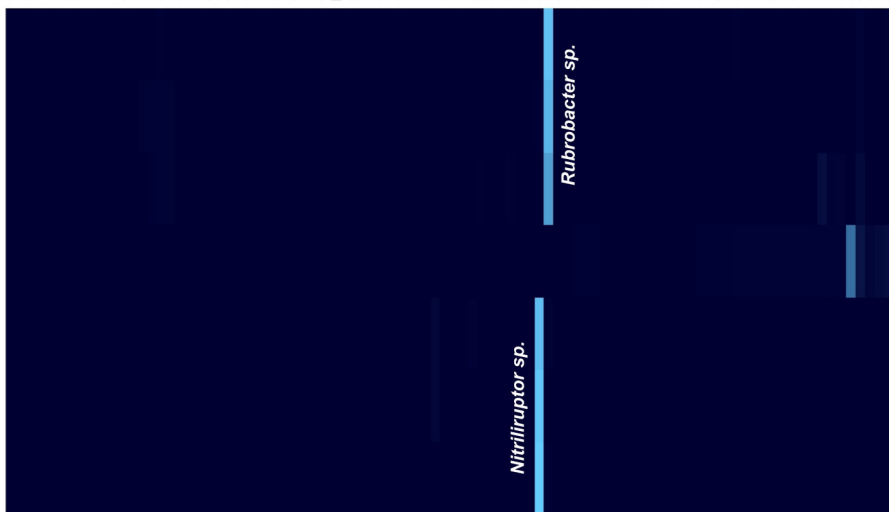
Taxonomy

737 W: white sample; P: pink sample; O: outgroup sample.

738 The most abundant genera are labelled in pale blue, while the less abundant genera are
739 labelled in dark blue. The dendrograms show the proximity between the different samples and
740 the proximity between identified bacterial genera.

362 The assignment of OTUs revealed that the majority of the bacteria found in the white and in
363 the pink area were Actinobacteria, while the outgroup sample was dominated by
364 Proteobacteria. Among Actinobacteria, the communities of white area samples were largely
365 dominated by the genus *Rubrobacter*, while the communities of pink area samples were
366 largely dominated by the genus *Nitriliruptor* (Fig. 4). Low proportions of *Rubrobacter* were
367 also detected in pink area and low proportions of *Nitriliruptor* were also detected in white
368 area. All other bacterial taxa detected in white and pink areas were in low proportions.
