# Experimental behaviour of an innovative demountable balcony with sophisticated connection

## Abstract

**Keywords:** *Demountable steel balcony, Embedded H-profile anchorage system, Hybrid bolted joints, Concrete contact pressure.*

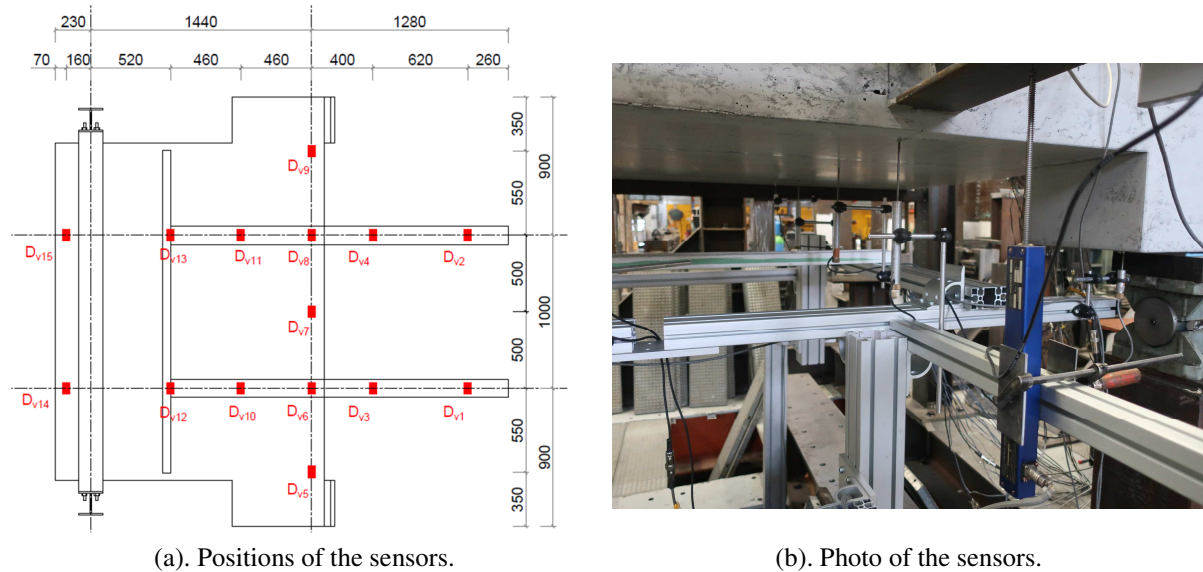
Figure 5. Displacement sensors (dimensions in mm).

The force generated by the hydraulic jack was measured with 3 force sensors: a DELTECH  $\pm 200$  kN and a double scale sensor  $\pm 500$  kN and  $\pm 1500$  kN. 4 LVDTs were used to measure the vertical displacements of two steel profiles (Dv1 to Dv4) and 11 LVDTs were installed to measure the vertical displacements of the reinforced concrete slab (Dv5 to Dv15). The position of the LVDTs are shown in Figure 5. Measured data were recorded every half second by a data acquisition system. Three extra LVDTs were also added in tests C1B and C1C in order to measure the opening between the edge beam and the concrete floor.

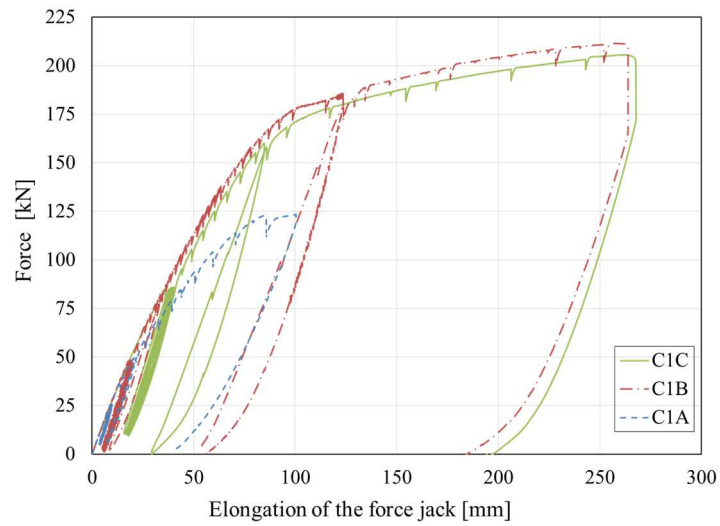
Figure 7. Force-displacement curve at the force jack.

Figure 7 shows the evolution of the force in function of the elongation of the force jack for the three tests. With respect to the specimen C1A, cracks started to appear during the initial 25 cycles of loading (5 kN – 25 kN) on the bottom surface of the concrete slab, right under the H-profiles (Figure 8a). These cracks then propagated towards the back of the slab with the increase in the load applied. During the cycle between 5 kN and 50 kN, inclined cracks appeared on both sides of each profile (Figure 8b and Figure 9), corresponding to a punching shear phenomena. Inclined cracks were also noticed on the lateral sides and on the bottom surface of the slab (Figure 10). Cracks due to bending behaviour of the slab were only seen at a higher applied load, close to the failure one (Figure 11). The failure happened when the applied load stopped increasing at around 125 kN and excessive opening of inclined cracks on the lateral sides were observed. The specimen failed in punching shear at the supports.

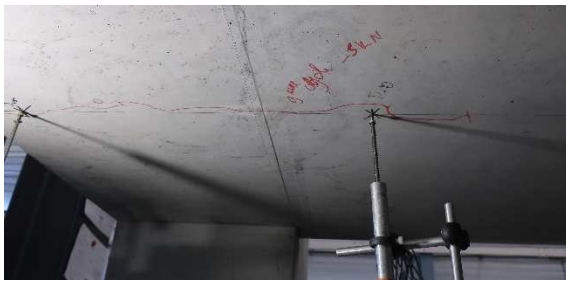
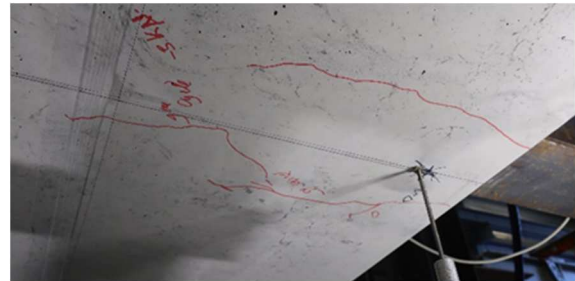
(a). During the 25 cycles between 5 and 25 kN.

(b). At estimated ultimate load.

Figure 8. Test C1A: cracks on the bottom surface of the reinforced concrete slab.

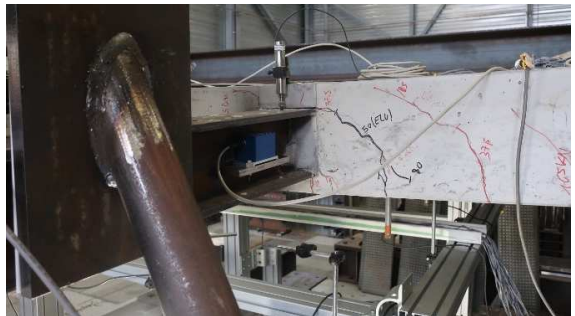
Figure 9. Test C1A: inclined cracks on the front surface of the reinforced concrete slab.

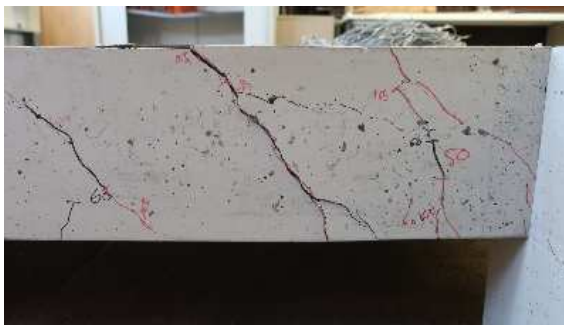
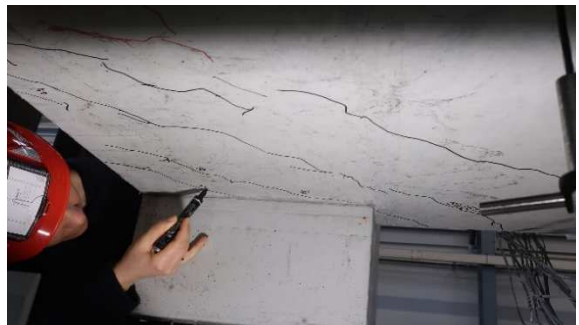
Figure 10. Test C1A: inclined cracks on lateral and on the bottom surfaces of the reinforced concrete slab.

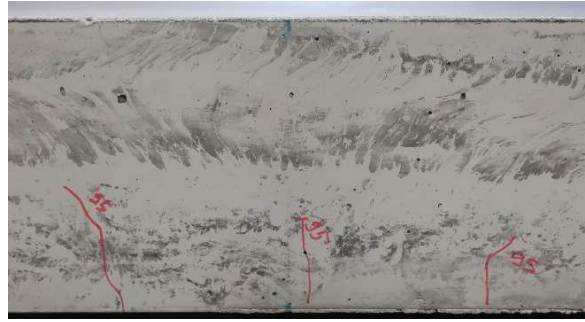
Figure 11. Test C1A: Vertical cracks at the middle span of the slab.

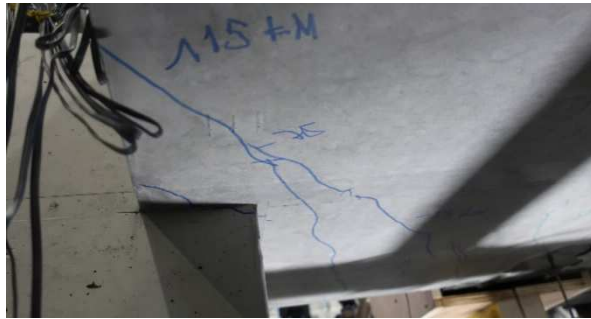
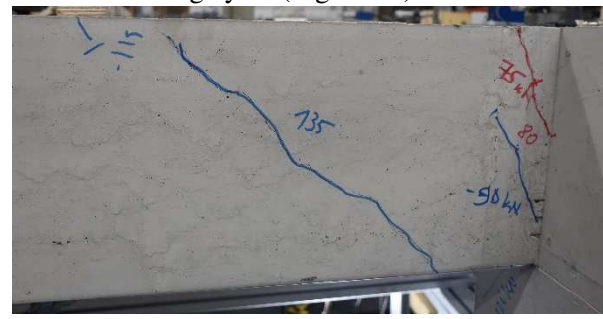
(a). Bottom surface.

(b). Lateral surface.

Figure 12. Test C1B: cracks due to punching shear.

For tests C1B and C1C, the punching shear phenomena were also observed at the supports of the concrete slab but with lower intensity (Figure 12). In addition, cracks also developed along the edge of the slab, causing the separation between the concrete slab and the steel edge beam (Figure 13). In the case of specimen C1C where a reinforced concrete lintel drop is present, vertical cracks were seen on both exterior and interior surfaces of the lintel since the first loading cycle (Figure 14).

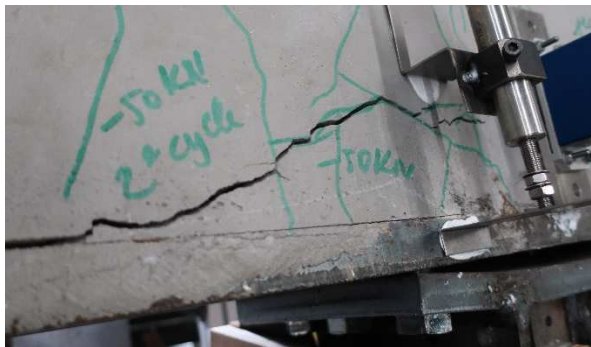
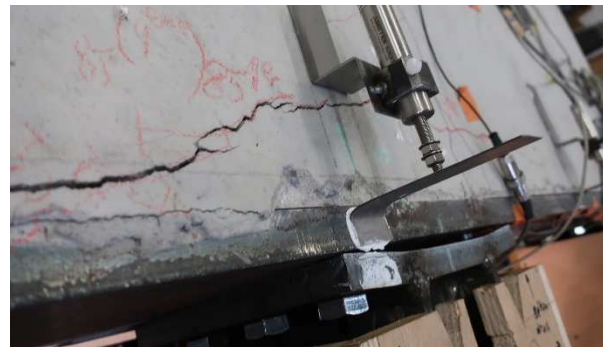
Figure 13. Crack due to the separation between the concrete slab and the steel edge beam.

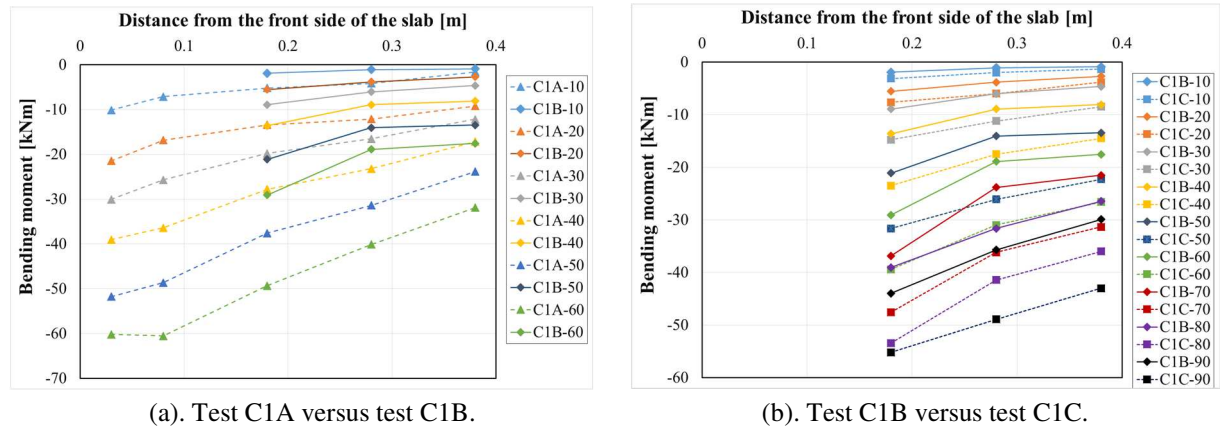
Figure 18. Distribution of bending moment in the embedded H-profile.

Figure 18 represents the comparison of the bending moment acting in the H-profiles for the three tests. The bending moment at the first two sections are missing in tests C1B and C1C due to the lack of data on the strain at the bottom flange of the profiles. It can be noted that the bending moment in the embedded H-profiles in test C1A is about two times larger than in test C1B. On the other hand, the bending moment obtained in test C1C is about 30% to 50% higher than in test C1B.
